# Doornboom rises from the mud

*The town of Heidelberg in the southwestern Cape is one of few where the original farmhouse of the settlement is still standing. A few years ago the old clay building was on the brink of collapse, but then a few dedicated volunteers took up the challenge of saving it. This is the story of the restoration, told by one of the volunteers*

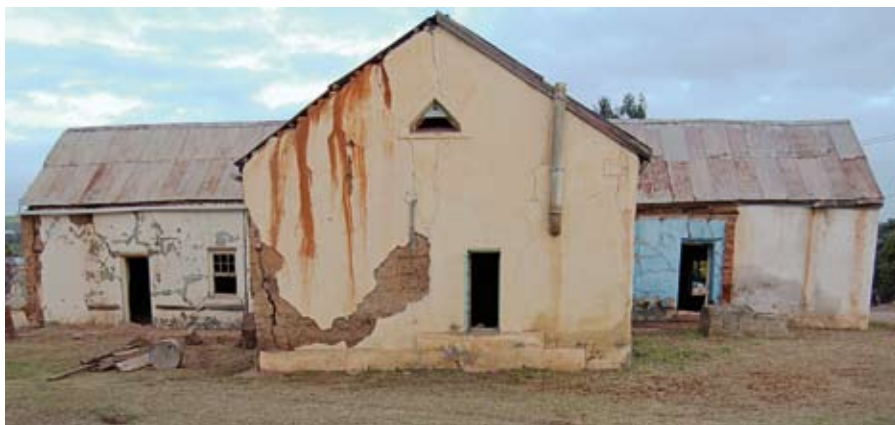
*The sadly neglected building as it looked in July 2005. The leaking gutters and corrugated iron roof fed water into the top of the walls, where it was trapped by the cement plaster. The part facing the camera, the leg of the T, is the oldest part of the structure*

Doornboom's corrugated iron roof (applied over the original thatch) and gutters leaked, channelling rainwater into the tops of the walls, from where it soaked downwards. Trapped inside the walls by the impervious cement rendering, the damp started softening the clay with disastrous results. When I first arrived at the Heidelberg site in the winter of 2006, the rain-soaked walls were toppling over one by one.

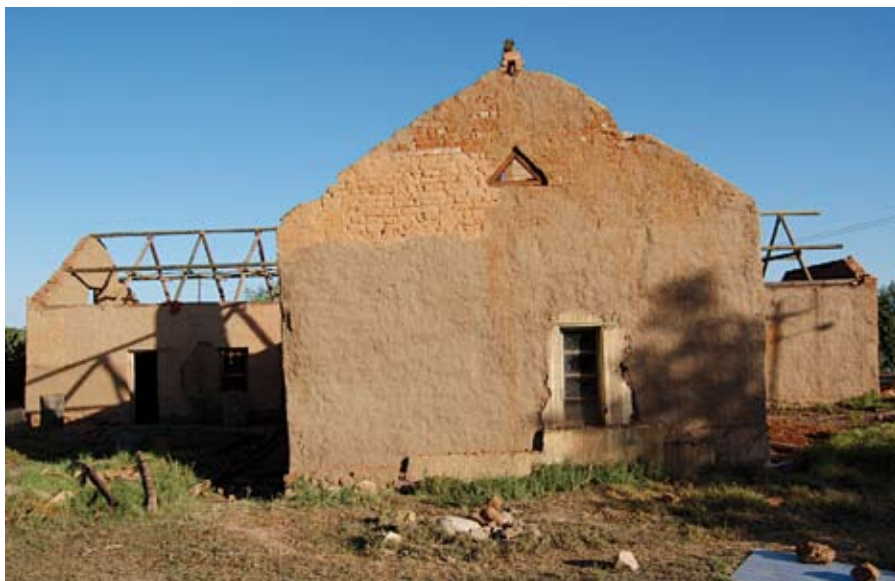
*The early stage of restoration, February 2007. All the cement plaster, as well as the roof, had been removed before the process of rebuilding could begin*

In the end it became necessary to rebuild or restore almost every outside wall, which was done using cob, with some critical sections of sun-baked bricks set in clay mortar. Once the walls had been rebuilt and window and doorframes refurbished or replaced, the iron roof was removed in order to prepare the roof structure for its new thatched roof.

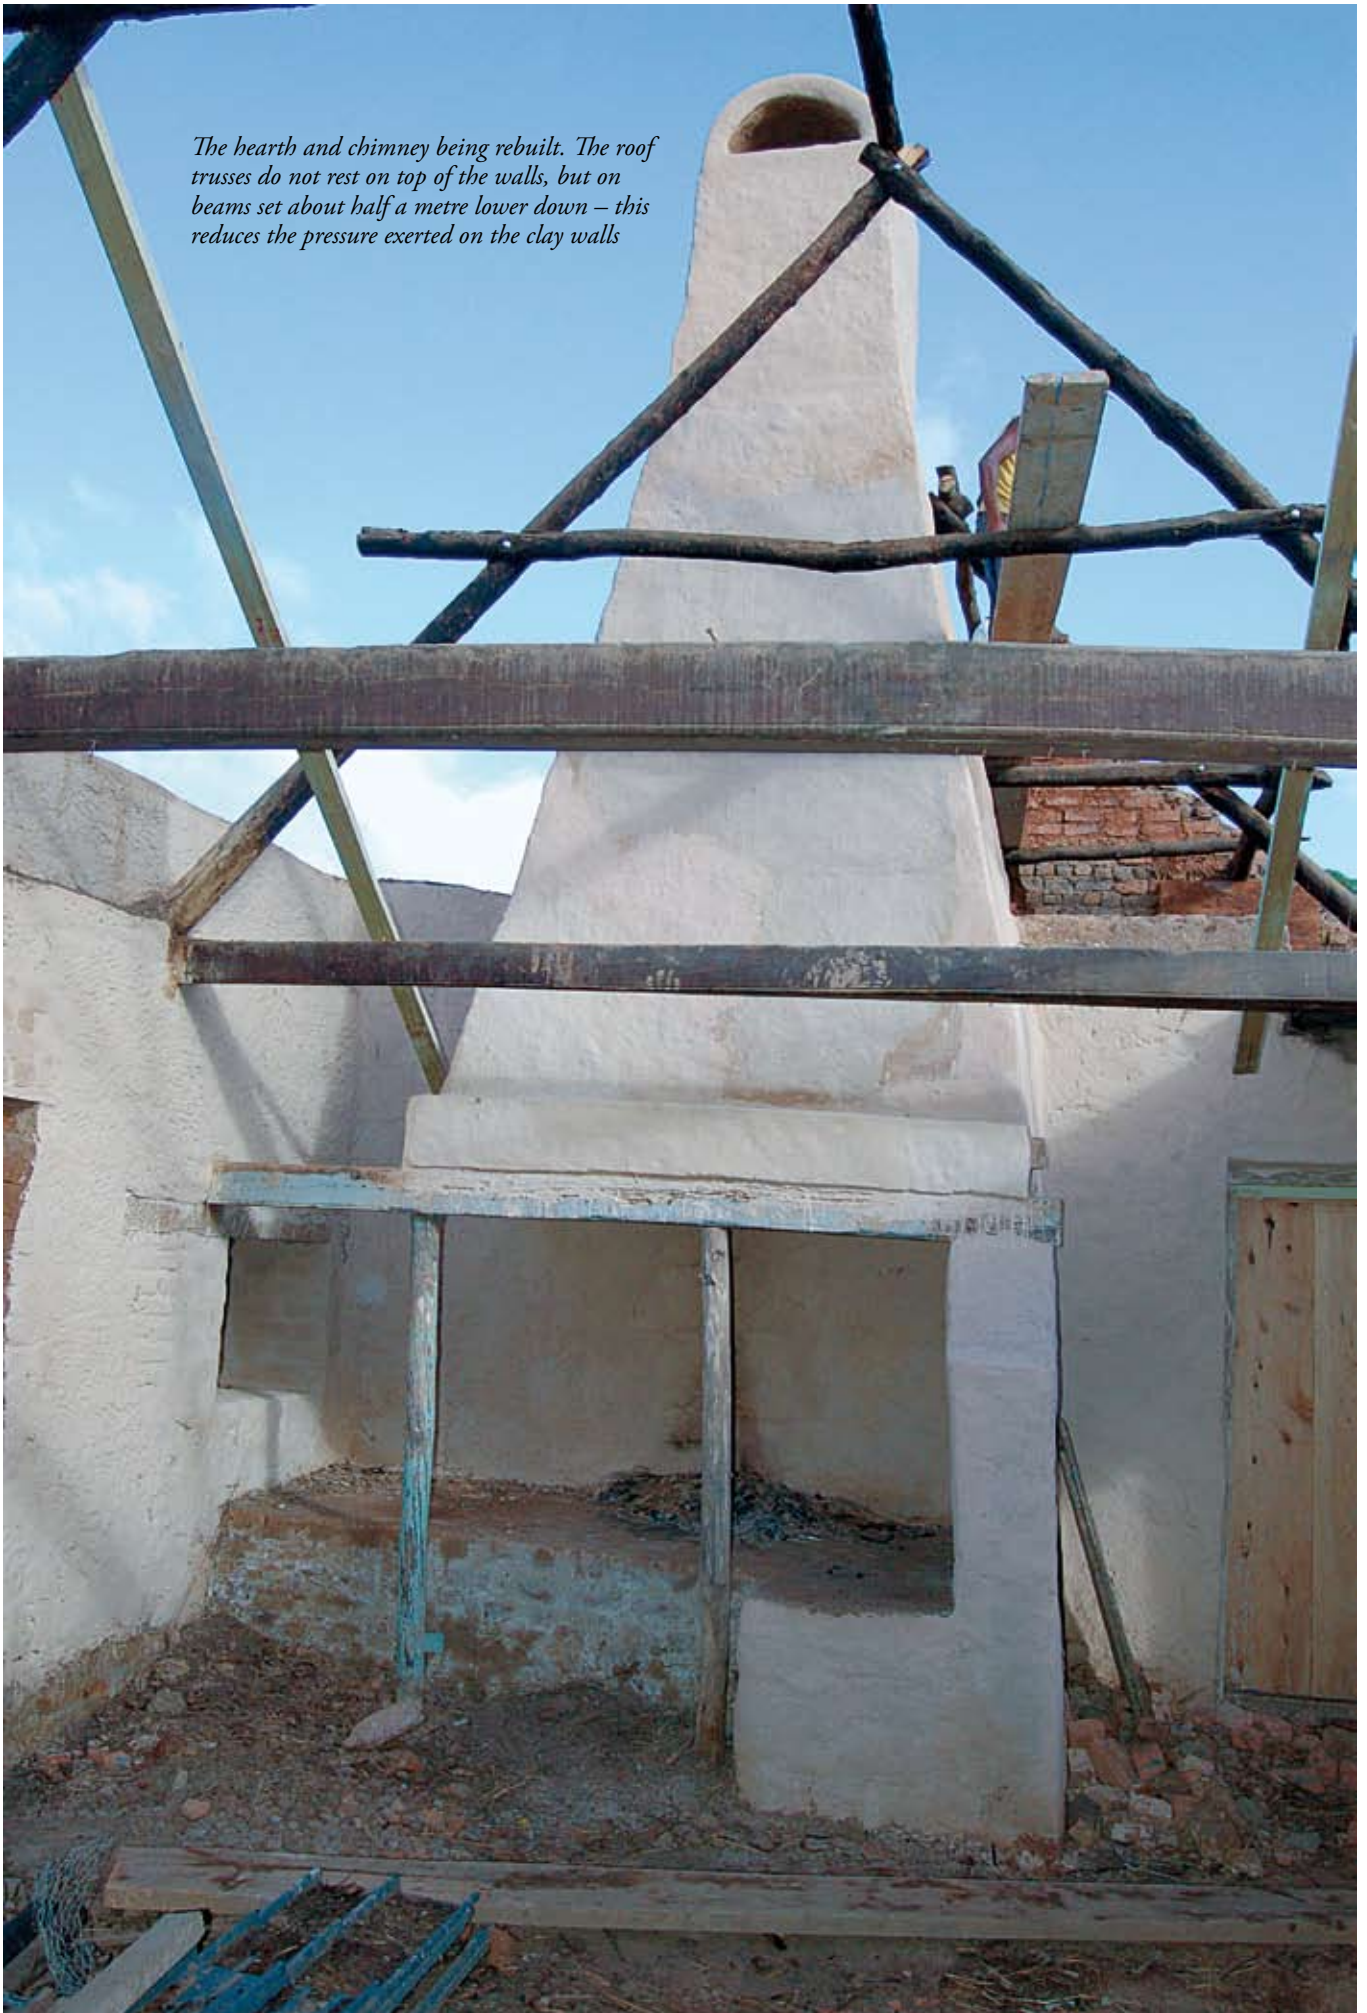
*The hearth and chimney being rebuilt. The roof trusses do not rest on top of the walls, but on beams set about half a metre lower down – this reduces the pressure exerted on the clay walls*

The roof beams and trusses were found to be structurally sound but the latter were strengthened during restoration to bear the weight of the heavier thatched roof. The original roof is of an unusual design, with the feet of the trusses resting on the ends of massive yellowwood beams, which are set in the walls. This arrangement feeds the splaying forces exerted on the trusses into the beams, rather than into the less resistant tops of the walls.

Because the beams are set about 500

cm below the tops of the walls, it means that the feet of the trusses stand inside the house. A secondary structure of additional, lighter trusses has been added to carry the eaves of the thatch roof outside the tops of the walls. This practice was apparently introduced by Malay craftsmen from the East.

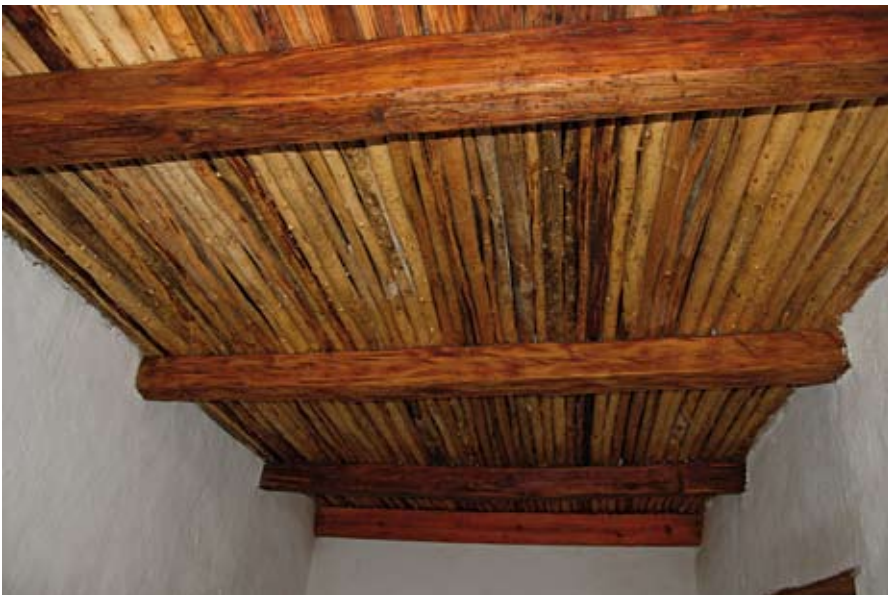
*The original roof supports were tied with leather thongs and rushes, intact after 250 years*

The top ends of the trusses were held together with rawhide thongs while the horizontal laths were lashed on with rushes. Amazingly, these elements were found to be completely sound even after 250 years. The timbers in the roof structure were also free of rot or beetle. The secret of this is the excellent natural preservative, fungicide and insecticide that was applied to them – juice from the abundant local aloes.

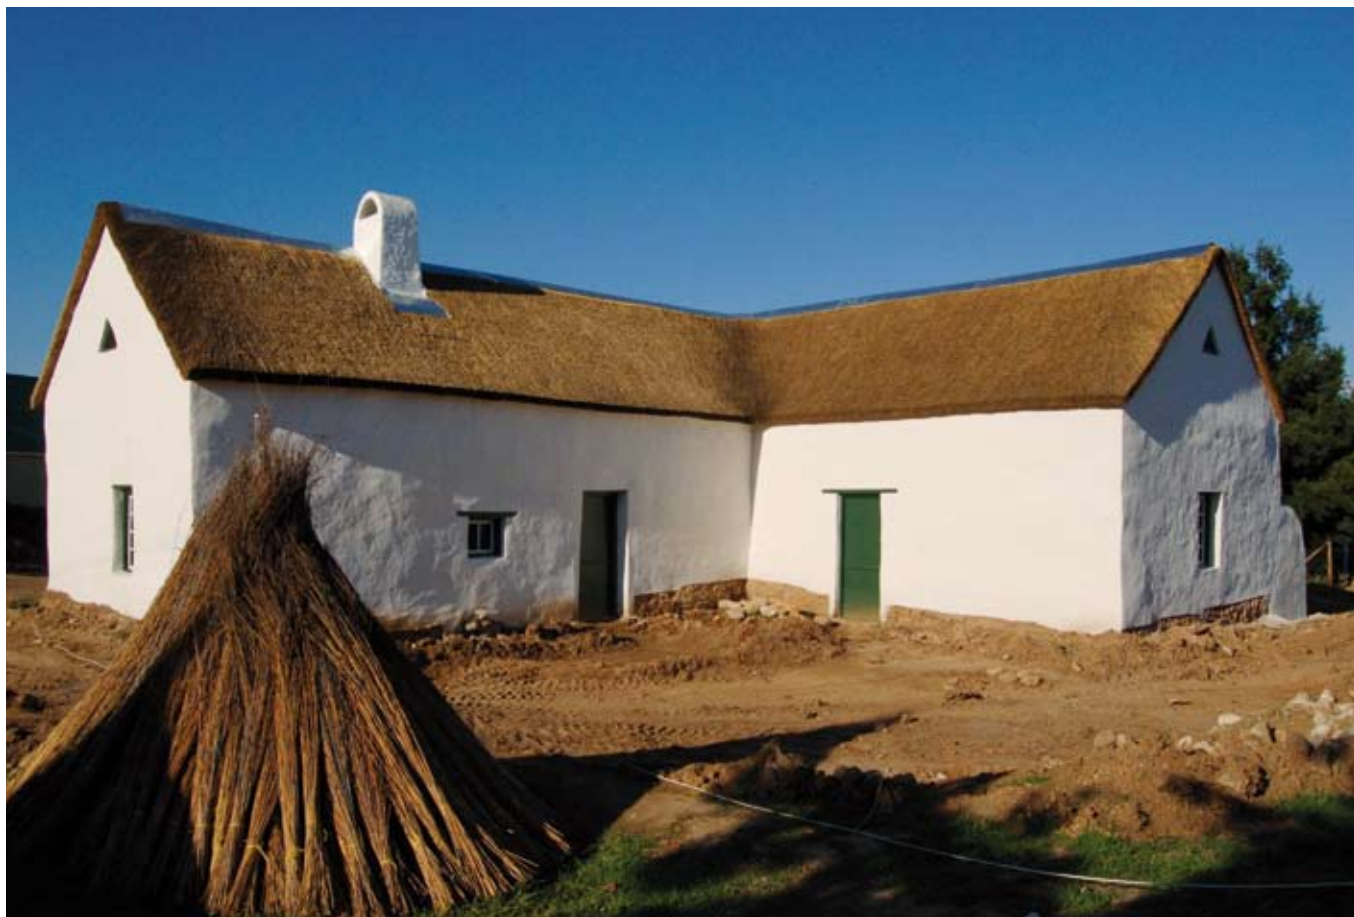
*Fourie House in June 2007, with its new thatched roof and lime-washed walls. The front of the house faces away to the right; the left-hand part is the leg of the T, comprising the original kitchen and storeroom*
